Nuffield and Leyland Tractor production took place at the Leyland Truck and Bus factory at Bathgate, West Lothian, Scotland. Many of the components required to build the tractor were produced 'In house'. The factory was arranged into five 'Blocks' 'A', 'B', 'C', 'D' & 'E'

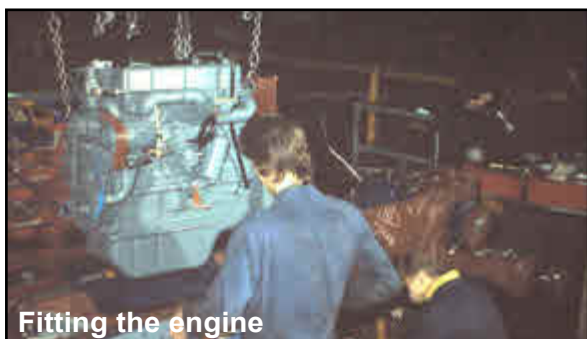
Fitting the engine

Tractor assembly started with the gearbox being placed on a stand fixed to the moving 'Track', both half axles were added followed by the main frame which had already been fitted with the front frame extension and front axle assembly. Once these had all been bolted together the engine would be lowered and bolted into place and the clutch shafts connected to the gearbox. (A different technique was employed for tractor models that didn't use cast main frames) The hydraulic unit and draw-bar or pick-up-hitch would also be added at this

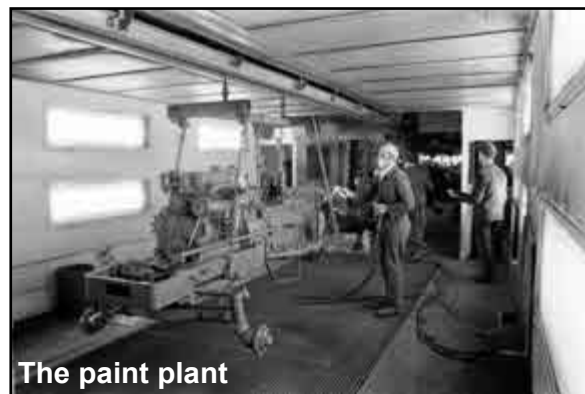
By this time the recognisable tractor was approaching the paint plant but before being lifted off the production line and entering the plant all excess grease and other contaminants were washed off. In the paint plant an 'Electrostatic' paint process was used to ensure the entire tractor was covered with paint. This process caused positive charged paint to be attracted to the negative surface to be painted with minimal paint 'Drift'. Once the tractor was painted it passed through a hot oven to 'Cure' the paint. All tin work and any other painted parts also passed through the same paint process.

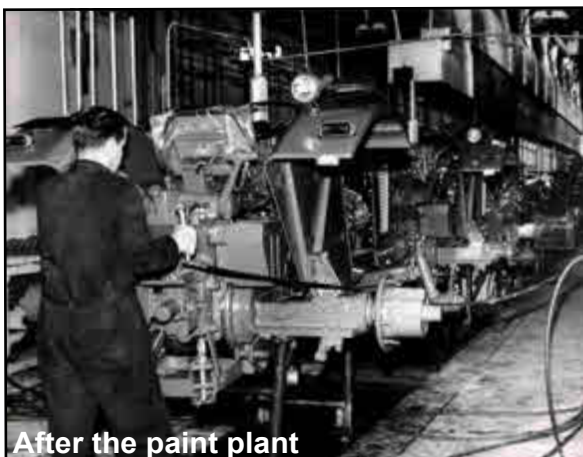
Once through the paint process, and moving on down the track, the visitor would see the tractor being lowered back onto the moving production line where the fuel tank was added, the fluids filled and grease points greased. Also at this stage the serial number plate would be riveted in place. Next the tin work and cab, which had been assembled to one side of the track, was added, once the cab was fitted the brakes and clutch cylinders were bled and the power steering filled and checked (All the tin work was pressed at the GKN Sankey factory in Wellington, Shropshire, the cabs were sourced from Sekura and other manufacturers) the pre-assembled wheels and tyres now arrived in the correct order, via overhead conveyers, to be fitted on the now near complete tractor.
